INSAG-7 The Chernobyl Accident: Updating of INSAG-1

A REPORT BY THE
INTERNATIONAL NUCLEAR SAFETY ADVISORY GROUP

**THE CHERNOBYL ACCIDENT: UPDATING OF INSAG-1
INSAG-7**

SAFETY SERIES No. 75-INSAG-7

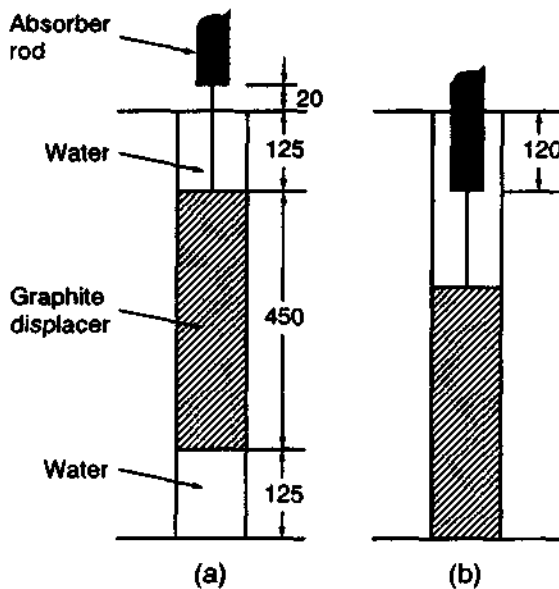
FIG. 1. Uppermost position of a control rod of the RBMK emergency protection system relative to the reactor core (a) before and (b) after the improvements made in response to the Chernobyl accident. Dimensions are given in centimetres.

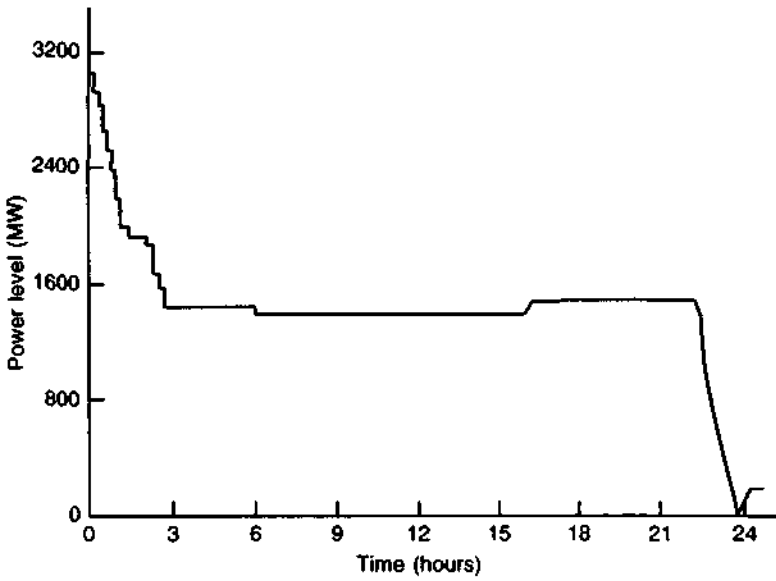
FIG. II-3. The Chernobyl accident: change in power level with time (from initiation of the power reduction).

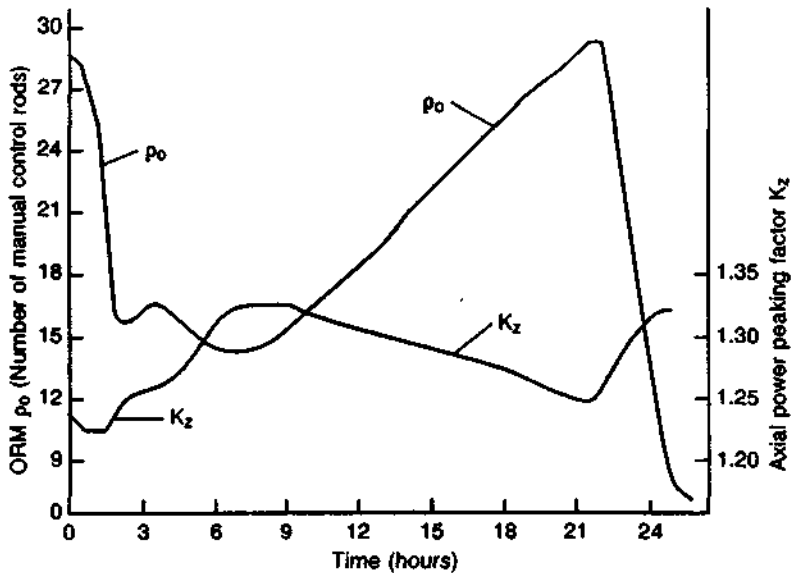
FIG. II-4. The Chernobyl accident: change in the operating reactivity margin ρ_0 and the power peaking factor (non-uniformity factor of the axial field) K_z during the transient.

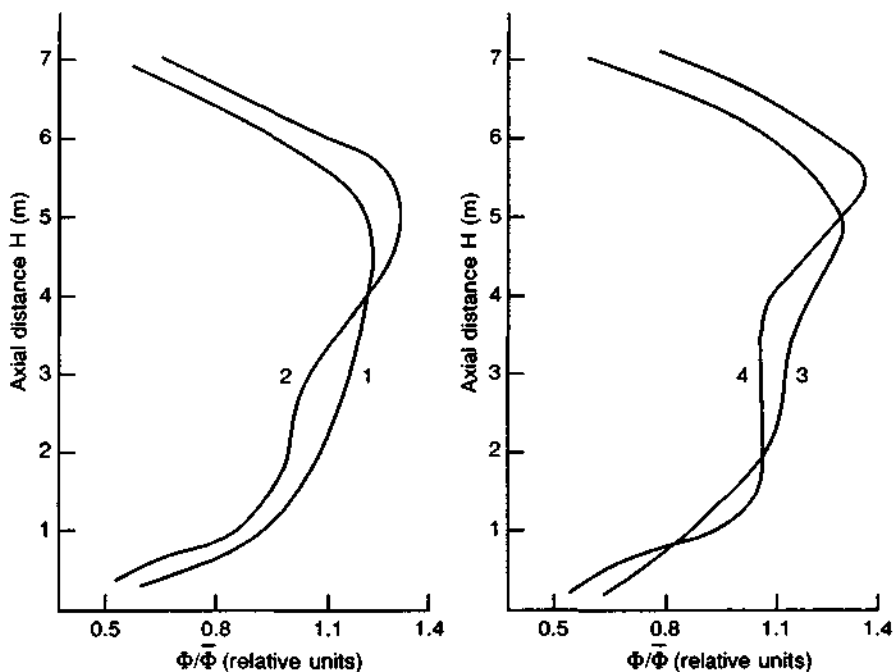
FIG. II-5. The Chernobyl accident: axial distribution of the thermal neutron flux density in the core at various times during the xenon transient preceding the accident: 1: 00:00; 2: 07:00; 3: 22:00; 4: 24:30 (before the accident).

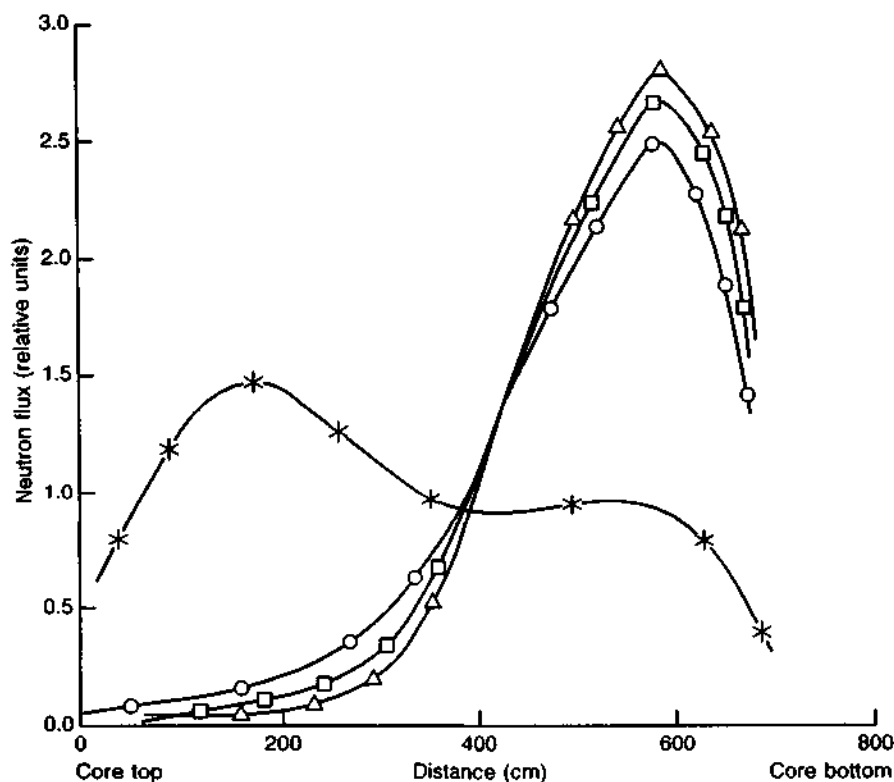
(Fig. II-9), and the reactivity and the integrated power level start to increase. Under abnormal conditions, this effect is caused by control rod design features: when the rod is inserted into the core from the top position (Fig. II-10), the multiplication factor in the bottom of the core increases owing to replacement of the neutron absorbing water column by the graphite displacer. The changes in the reactivity and the integrated power level which were generated by Model 1 are shown in Fig. II-11.

However, one fact cannot be avoided: none of the three models reproduces the reactor runaway when, three seconds after EPS-5 is triggered, signals are generated indicating that the emergency set points for the power level and the rate of power rise have been exceeded.

FIG. II-9. The Chernobyl accident: distortion of the axial neutron fields during rod insertion at the time when the accident occurred. The displacement of the neutron flux maximum to the lower part of the core is clearly shown. Key: time after EPS-5 button was pressed: *: 0 s; o: 4 s; □: 6 s; Δ: 7 s.

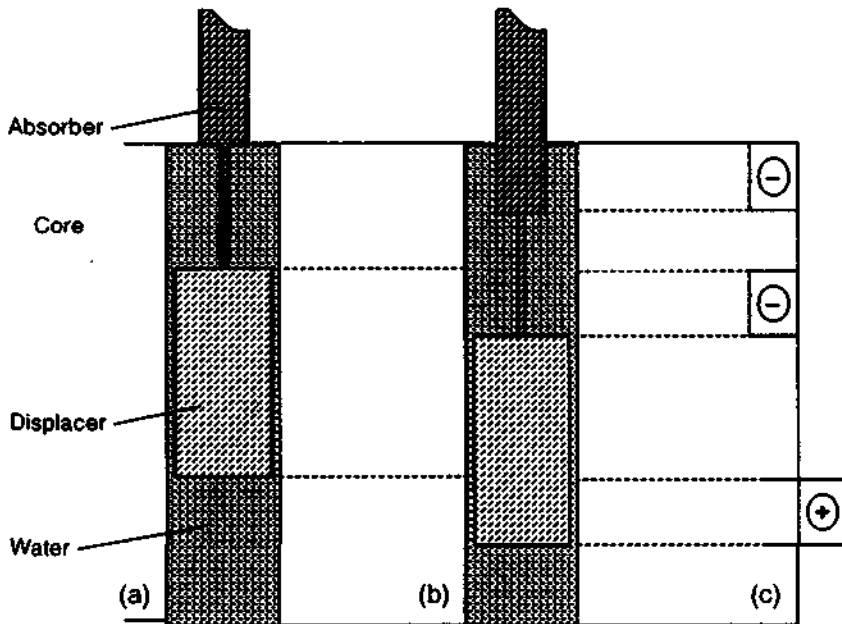
FIG. II-10. The RBMK reactor: schematic representation of the reactivity insertion caused by inserting the RCPS rods from the top position. (a) Manual control rod withdrawn; (b) manual control rod partially inserted; (c) the change in the theoretical reactivity insertion δk_{∞} as the rod is inserted.

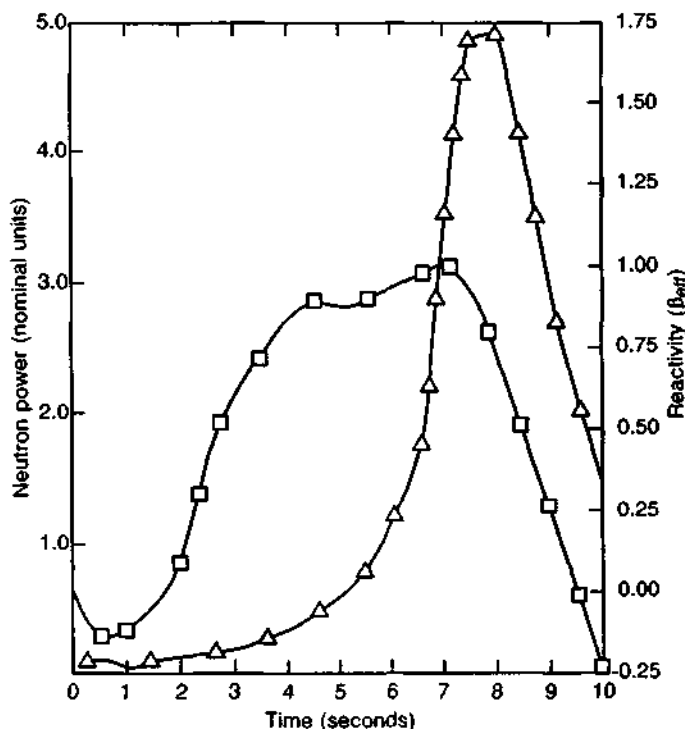
The main factors that affected the accident sequence were the positive void reactivity effect and RCPS design deficiencies which caused the insertion of positive reactivity under the reactor conditions prevailing prior to the accident. These conclusions underlie the measures which were elaborated to improve the safety of plants with RBMK reactors.

FIG. II-11. The Chernobyl accident: time dependence of the reactivity level and the neutron power during the initial phase of the accident. \square : reactivity; Δ : neutron power. [Reactivity is expressed in units of effective delayed neutron fraction β_{eff} .]

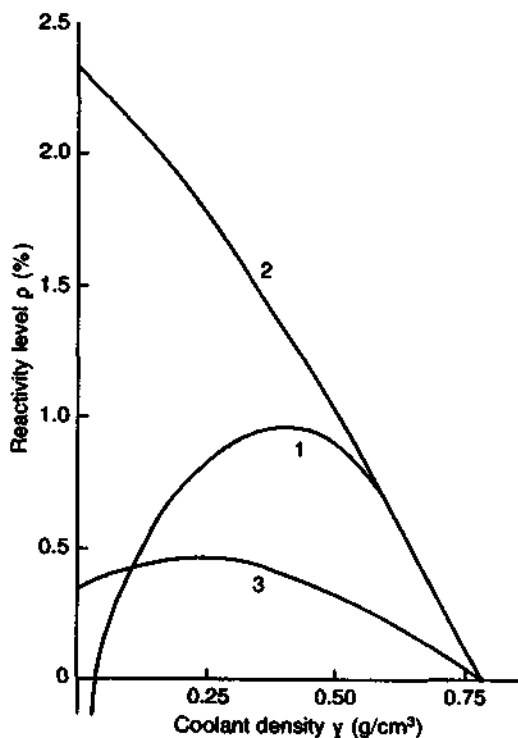
FIG. II-12. The RBMK reactor: dependence of the reactivity level ρ on the coolant density γ . 1: design calculations; 2: actual dependence at the time when the accident occurred on 26 April 1986; 3: current status after improvements.

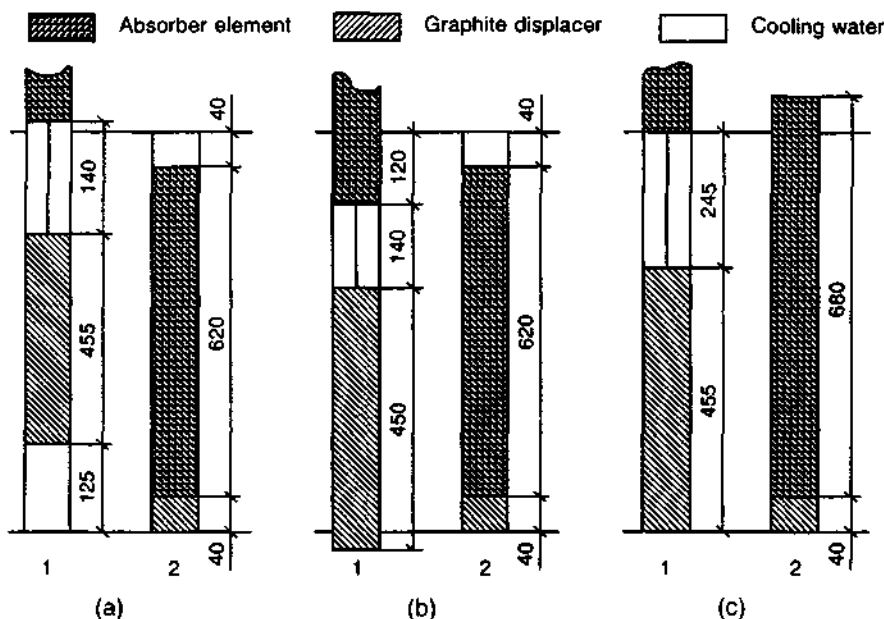
FIG. II-13. Manual control rods in the RBMK reactor. (a) old design rod; (b) old design rod inserted into the core to avoid the insertion of positive reactivity; (c) retrofitted rod. 1: rod withdrawn; 2: rod inserted. [Dimensions are given in centimetres.]

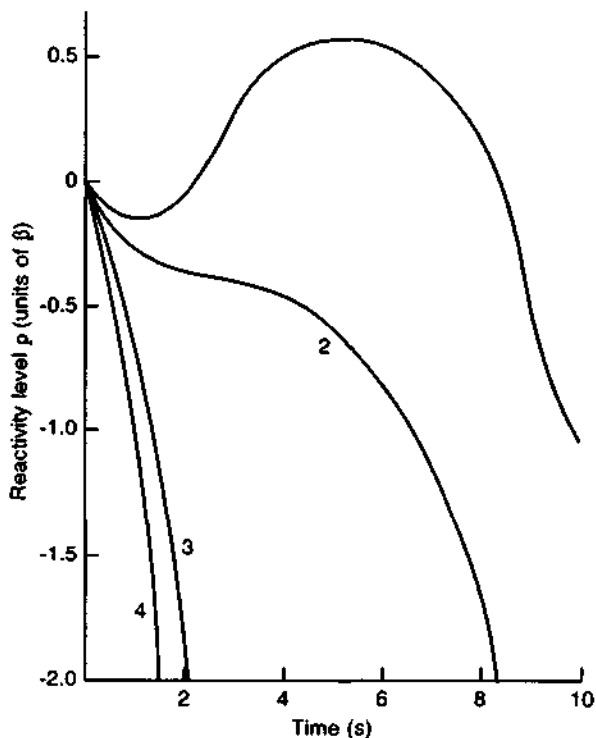
FIG. II-15. The RBMK reactor: efficiency of the emergency protection system. 1: the Chernobyl plant on 26 April 1986, ORM = 7 manual control rods (DBA conditions); 2: ORM as specified in the Operating Procedures (15 manual control rods); 3: retrofitted RCPS, ORM = 30 manual control rods; 4: retrofitted RCPS, fast acting emergency protection system in operation.
