INSAG-7 The Chernobyl Accident: Updating of INSAG-1

A REPORT BY THE
INTERNATIONAL NUCLEAR SAFETY ADVISORY GROUP

**THE CHERNOBYL ACCIDENT: UPDATING OF INSAG-1
INSAG-7**

SAFETY SERIES No. 75-INSAG-7

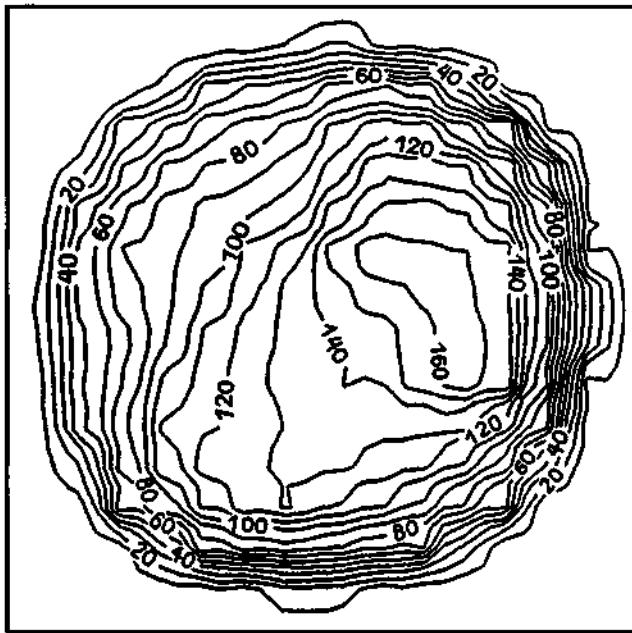
FIG. II-7. The Chernobyl accident: radial distribution of the initial neutron field in the core.

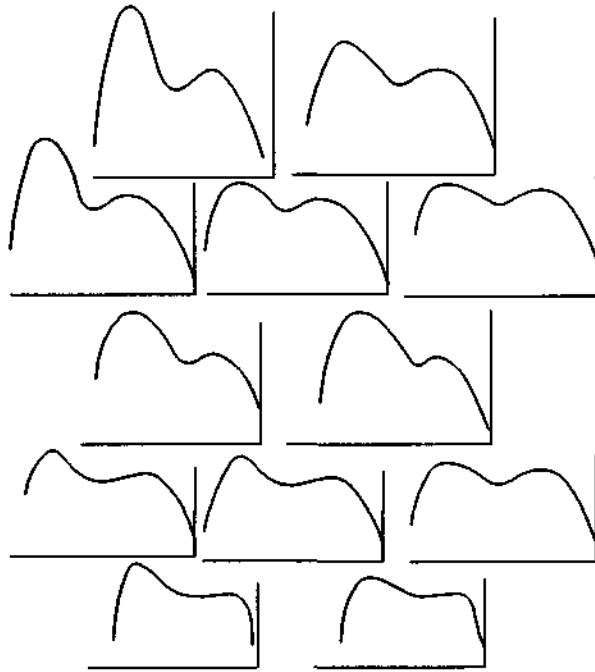
FIG. II-8. The Chernobyl accident: distribution of the power density profile over the core volume as recorded by the axial detectors.

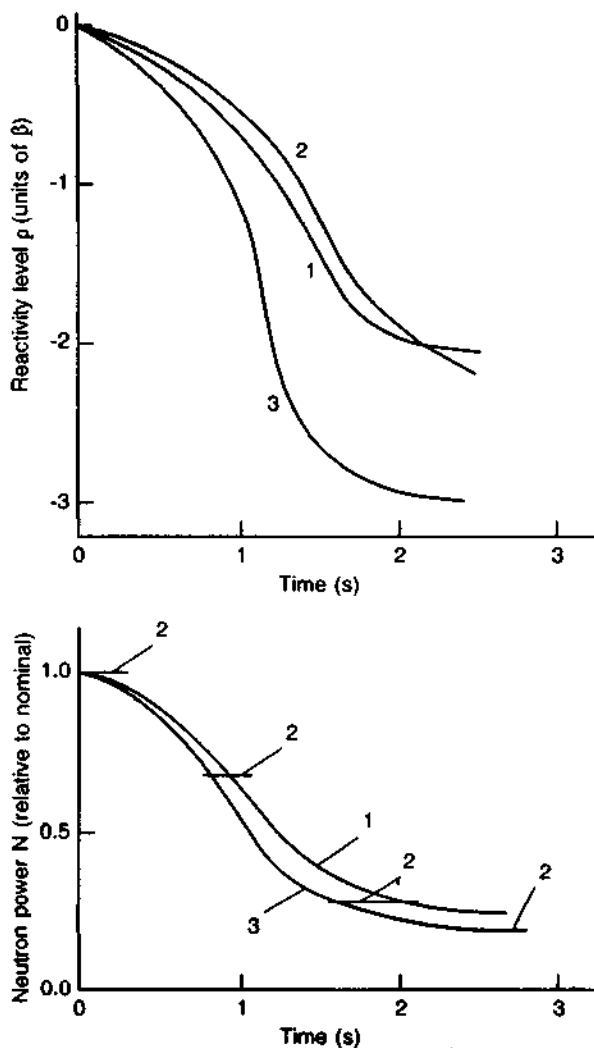
FIG. II-14. The RBMK reactor: reactivity level ρ and neutron power N : testing of the fast acting emergency protection system at the Leningrad and Ignalina nuclear power plants. $N_p = 0.4 N_{nom}$. 1: theoretical calculations; 2: experiment at the Leningrad plant; 3: experiment at the Ignalina plant.
